CITY OF CRAIG
REQUEST FOR PROPOSALS
DESIGN AND ENGINEERING SERVICES

Craig False Island Dock Cathodic Protection Project

CRAIG HARBORS CONDITION ASSESSMENT OCTOBER 2020

FALSE ISLAND INDUSTRIAL DOCK

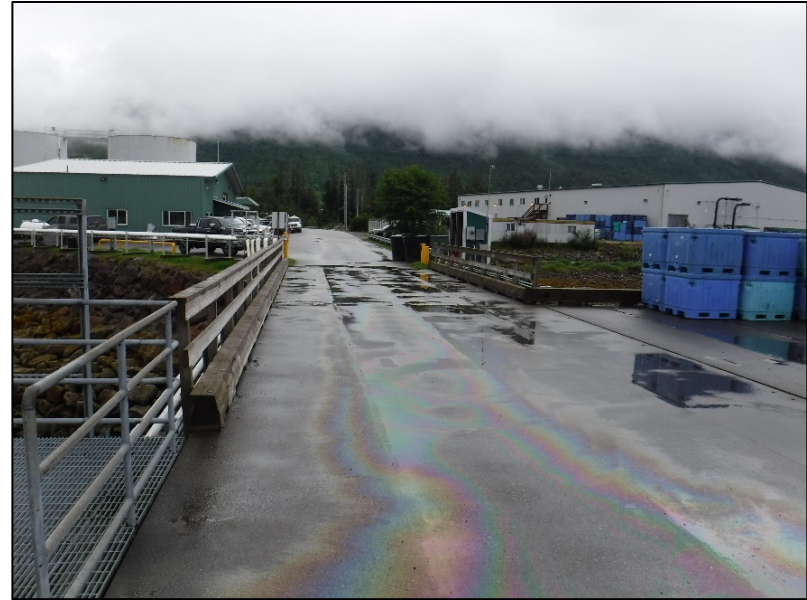
Ponding of water on approach dock deck.

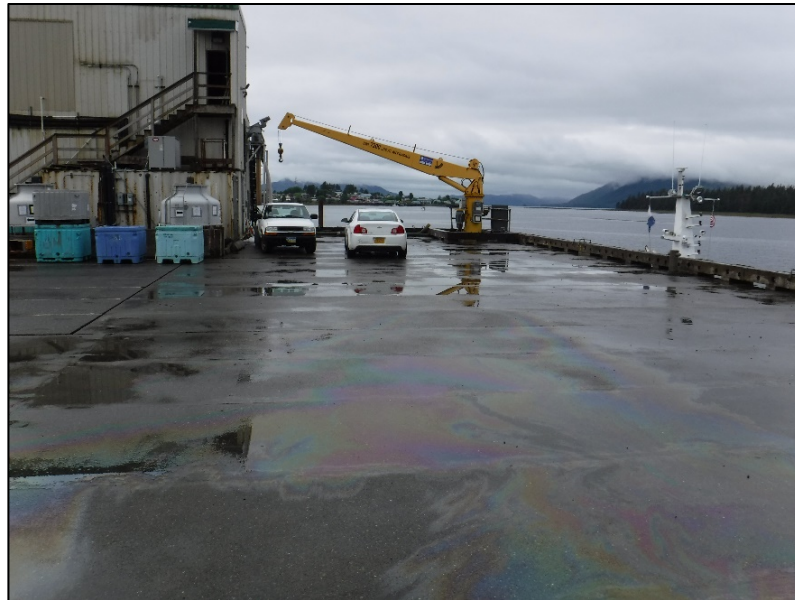
Typical ponding of water on main dock deck.

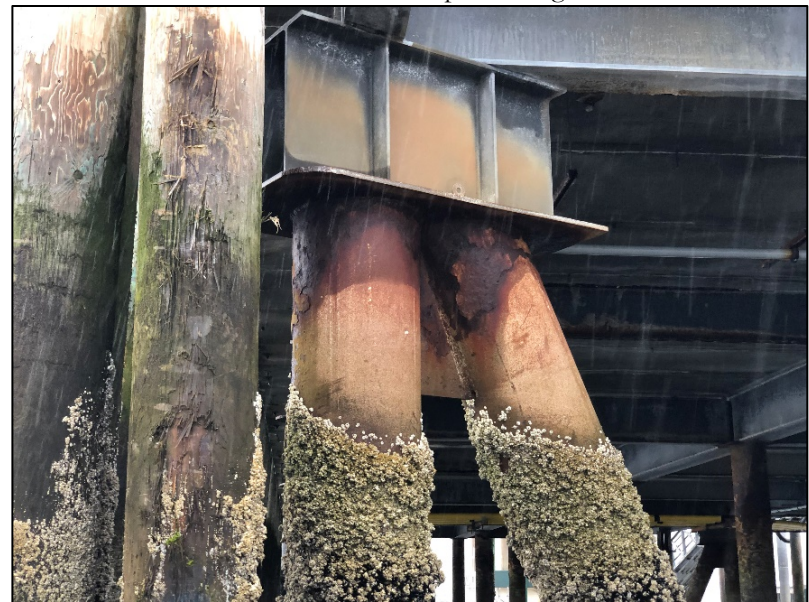
- **Steel Support Piles** – In the splash zone and below, nearly all of the original protective coatings on the steel pipe piles is gone and pile base metal is actively being lost due to the absence of any corrosion protection system. However, at this point in time only minimal loss of pile base metal was measured and similar conditions were observed during the dive inspection at the lower tidal elevations and at mudline. The top 5-ft of pile, near the pile to pile cap connection, is corroded with heavy rust scale appearing on all sides of the pile. Galvanized coatings in this zone are in poor condition, but base metal remains intact.

Typical corrosion of steel dock piles in splash zone (above water).

- **Steel Piles and Superstructure** – The facility is over 20 years old and is in need of attention to maintain and/or extend the intended design service life. In particular, the protective coatings for virtually all steel components have exceeded their useful life and are no longer serving their intended purpose. Of chief concern is steel section loss due to corrosion which translates to reduced structural capacity which would in effect render the dock unsafe and not useable. As a minimum and the short-term goal should be to install adequately sized anodes on all steel piles.

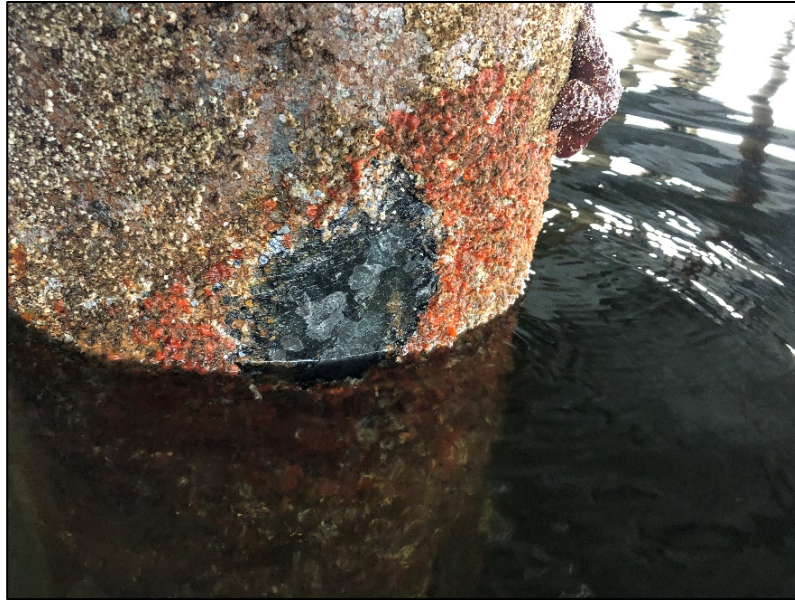
Typical dock support pile surface condition in tidal zone.

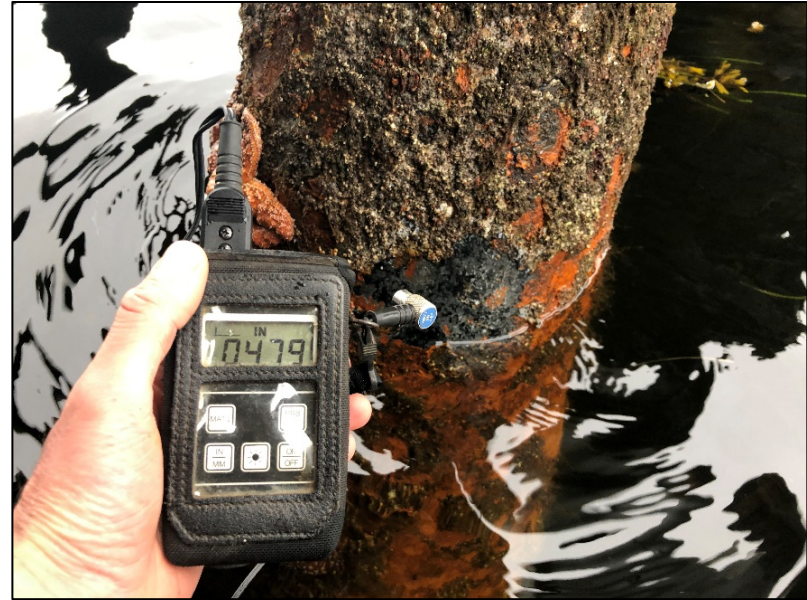
Steel dock pile thickness measurement.

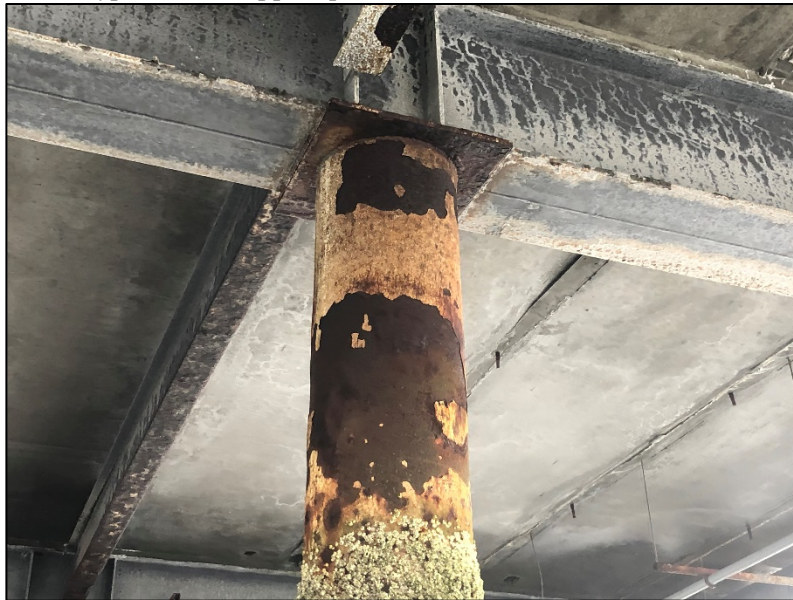
Typical corrosion of steel dock pile in splash zone.

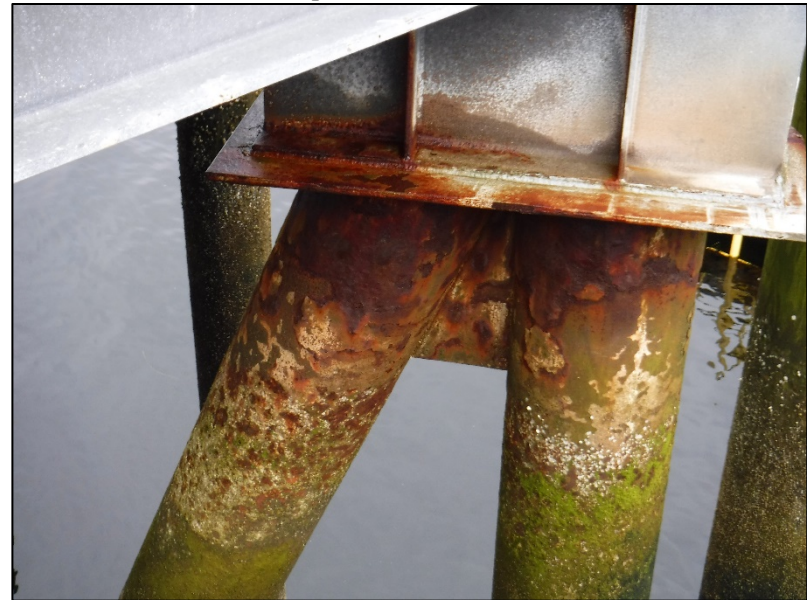
- **Steel Pile Caps and Diaphragms** – The steel pile caps and diaphragms are generally in fair to good condition. Galvanized coatings at the pile to pile cap connection (area where field welding was performed) are gone and base metal is coated with heavy surface rust. In many locations the lower pile cap flange is rusted full-length of the beam.

Typical corrosion of vertical/batter pile sub-cap weldment.

In the long-term, more comprehensive repairs should be done to protect the piles and dock superstructure. The environment, and consequently the condition of the protective coatings, varies with elevation along the piles. Therefore, it is recommended that providing corrosion protection for the dock and dolphin piles should consist of a three-part system. In the intertidal and submerged zones, it is recommended that sacrificial anodes be installed to effectively reduce the rate of corrosion. Secondly, in the splash zone, it is recommended that petroleum pile wraps with protective outer jacketing be utilized. This system has a proven history of effectively sealing off oxygen which significantly reduces the rate of corrosion. Finally, for the areas where the piles transition to the pile caps and the pile caps themselves, it is recommended the steel be blasted, spray metalized and top-coated with a clear protective layer.

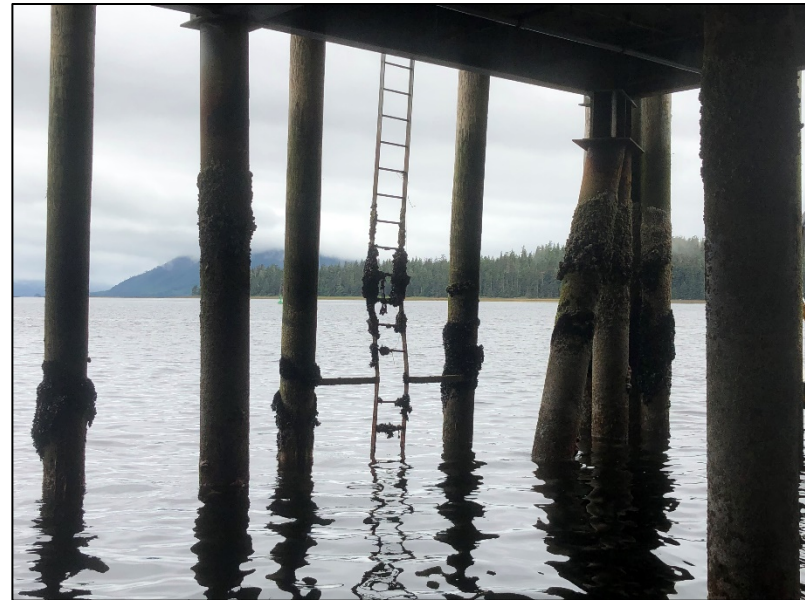
- **Safety/Access Ladders** – The ladders are in poor condition. The lower portions of the ladders are significantly deteriorated with some loss of steel due to corrosion and several with missing rungs making them unsafe and unusable at lower tidal elevations. In addition, many of the ladders are bent due to vessel impact and the connection which secures the ladders to the fender piles has become detached and hence the ladders are loose and unstable.

Typical corroded/damaged access ladder.

- **Safety/Access Ladders** – Although the ladders are in good condition at higher elevations, the ladders are not safe to use at their lower elevations. It is recommended that all ladders be replaced along with all associated connection hardware.

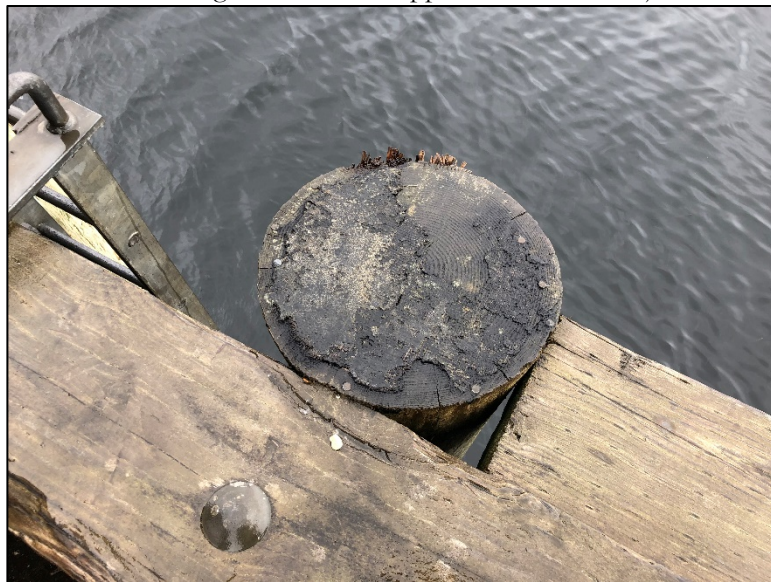
- **Fender Piles** – The timber fender piles are in overall good condition with a few exceptions. One of the main (west) dock face fender piles has been damaged/broken, and rot was identified near the location of an access ladder connection bolt. Minor mechanical wear was observed due to vessels berthing against the fender piles but they are in overall good, sound condition. The fender pile tops have remnants of a mastic tar paper installed that is intended to prevent water intrusion into the pile end grain. These original protective coverings are nearly all missing. Chocking between dock fender piles is in good condition.

Typical deterioration of fender pile end covering.

- **Fender Piles** – A competent fender system is critical to the longevity of a dock. It is the single-line of defense which serves to protect the dock from berthing vessels and/or floating debris. Absorption of water into the end grain of the piles and the subsequent development of rot in the wood is a common problem with dock fender piles. This condition has generally been avoided thus far due to the original installation of the pile top coverings. However, it is recommended that the coverings be replaced. Due to the proximity of adjacent piles, the broken fender pile along the south end of the dock face is not an immediate concern, but it is recommended that it be replaced when possible.

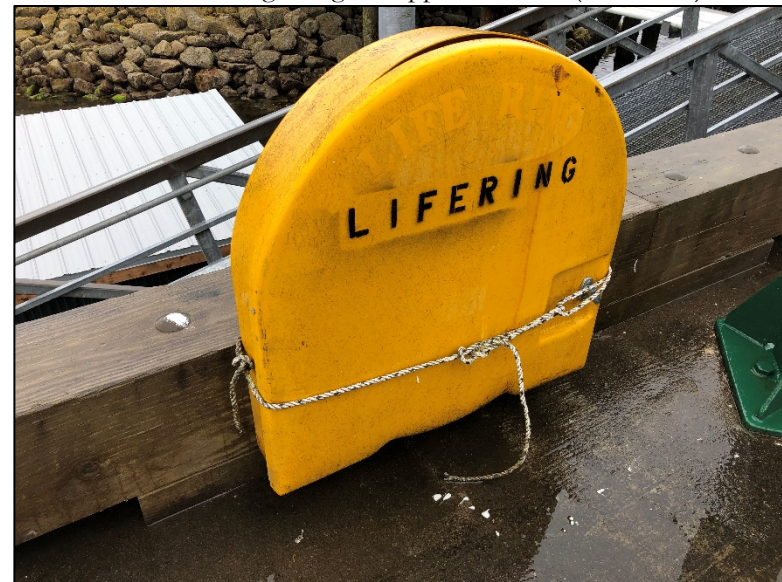
- **Life Ring Cabinets** – One life ring cabinet exists at the northeast corner of the dock. The cabinet is currently being held closed with nylon rope due to the door hinges being damaged.

Life ring cabinet w/ broken door hinge assembly.

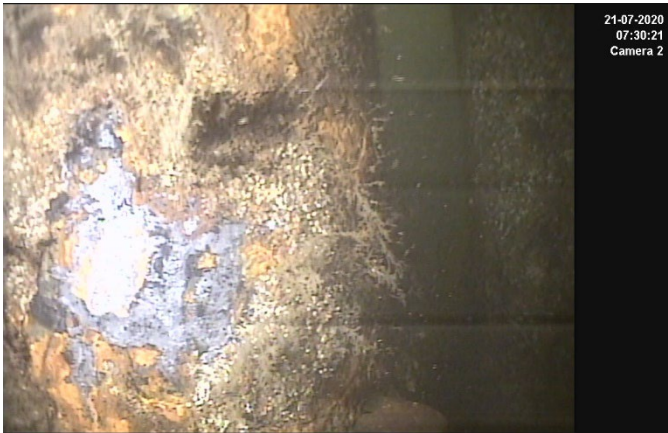
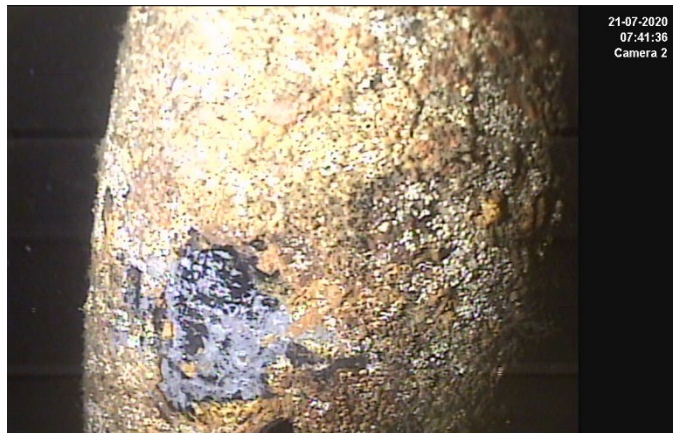
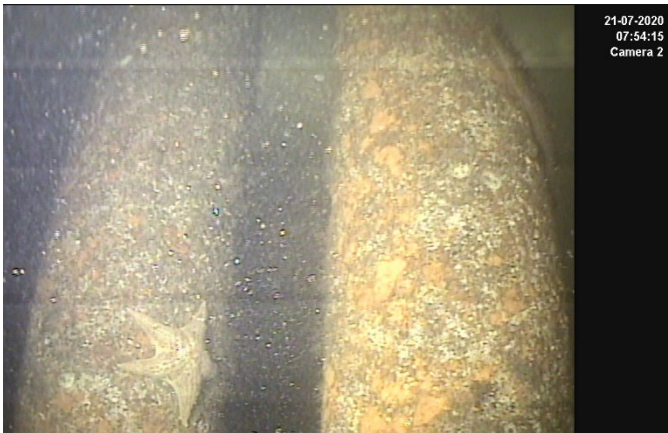
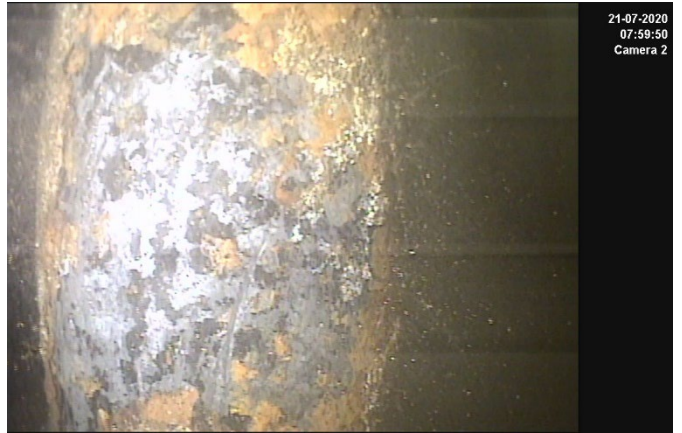
INDUSTRIAL DOCK: Steel pile

Findings: All of the piles inspected under the industrial dock building and along pier were steel. All steel piles were in 'GOOD' condition with minor pitting and surface rust.

Recommendations: Steel piles being retro-fitted with weld on sub-surface anodes just above mudline to extend life of piling.
