CITY OF CRAIG
REQUEST FOR PROPOSALS
DESIGN AND ENGINEERING SERVICES

Craig False Island Dock Cathodic Protection Project

CRAIG HARBORS CONDITION ASSESSMENT OCTOBER 2020

FALSE ISLAND INDUSTRIAL DOCK

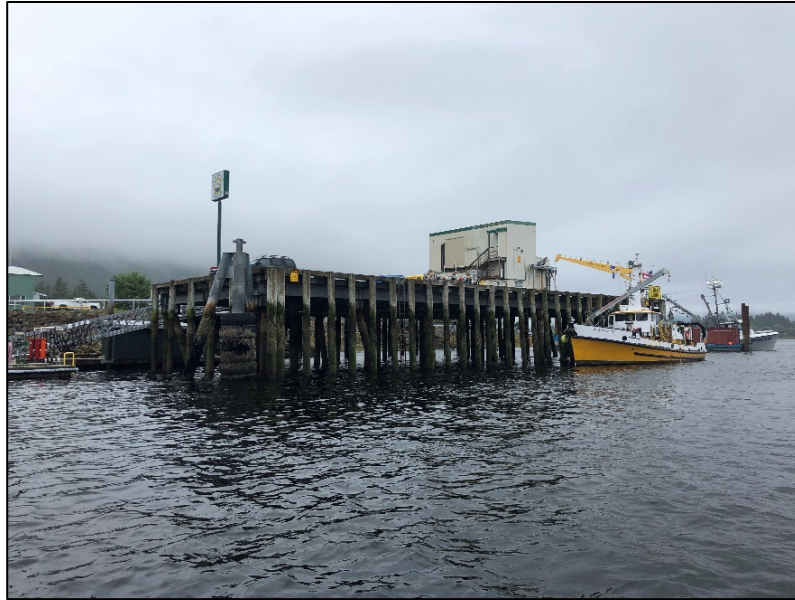
Overview of dock face.

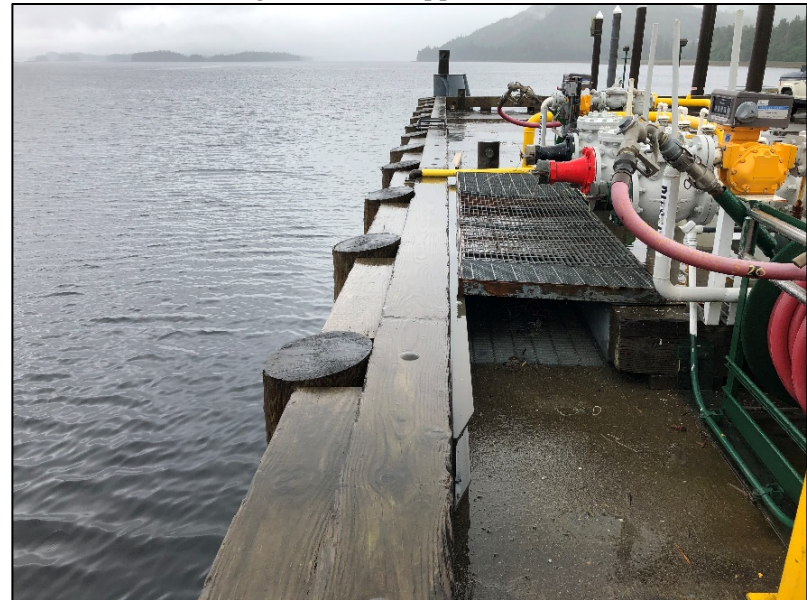
- **Timber Bullrail/Curb and Railing** – The timber bullrail is in good condition with only minor mechanical wear observed. The timber approach dock railing is also in good condition.

Timber bullrail/curb and fender piles at dock face.

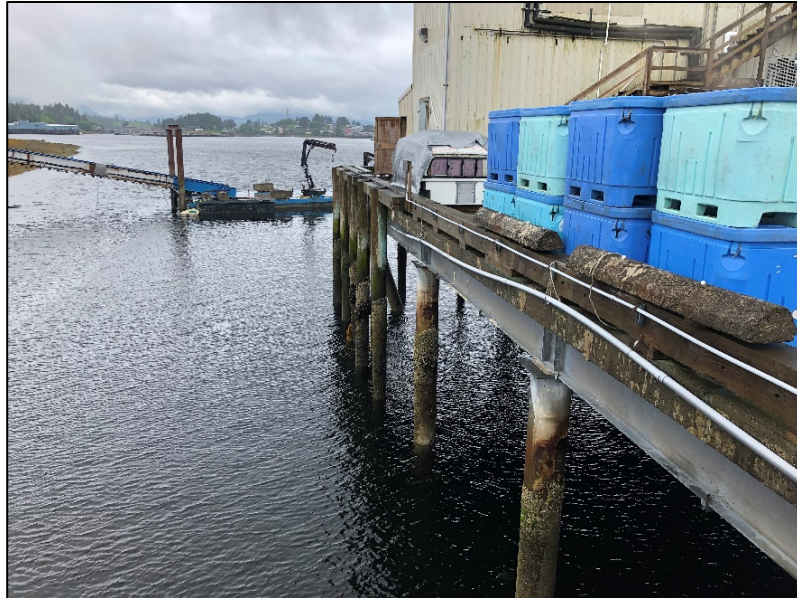
Overview of backside of main dock.

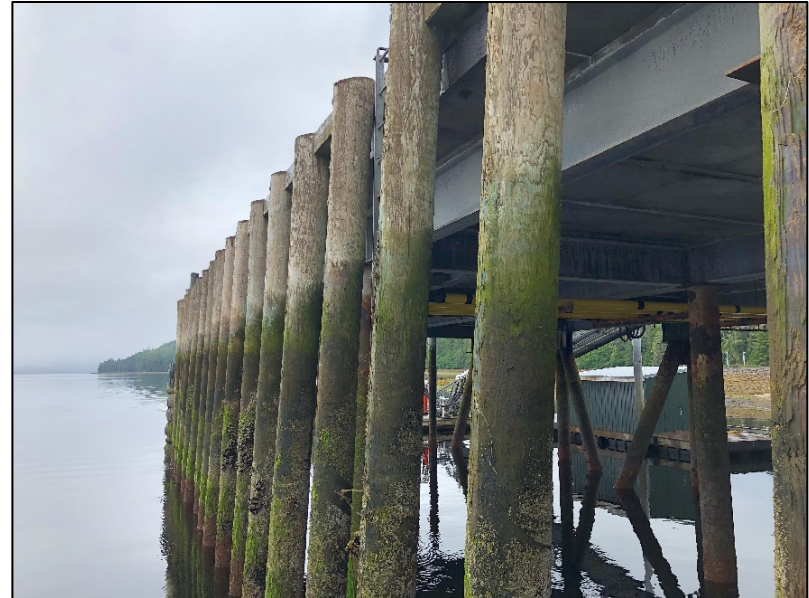
- **Fender Piles** – The timber fender piles are in overall good condition with a few exceptions. One of the main (west) dock face fender piles has been damaged/broken, and rot was identified near the location of an access ladder connection bolt. Minor mechanical wear was observed due to vessels berthing against the fender piles but they are in overall good, sound condition. The fender pile tops have remnants of a mastic tar paper installed that is intended to prevent water intrusion into the pile end grain. These original protective coverings are nearly all missing. Chocking between dock fender piles is in good condition.

Overview of timber fender piles along dock face.

- **Fender Piles** – A competent fender system is critical to the longevity of a dock. It is the single-line of defense which serves to protect the dock from berthing vessels and/or floating debris. Absorption of water into the end grain of the piles and the subsequent development of rot in the wood is a common problem with dock fender piles. This condition has generally been avoided thus far due to the original installation of the pile top coverings. However, it is recommended that the coverings be replaced. Due to the proximity of adjacent piles, the broken fender pile along the south end of the dock face is not an immediate concern, but it is recommended that it be replaced when possible.

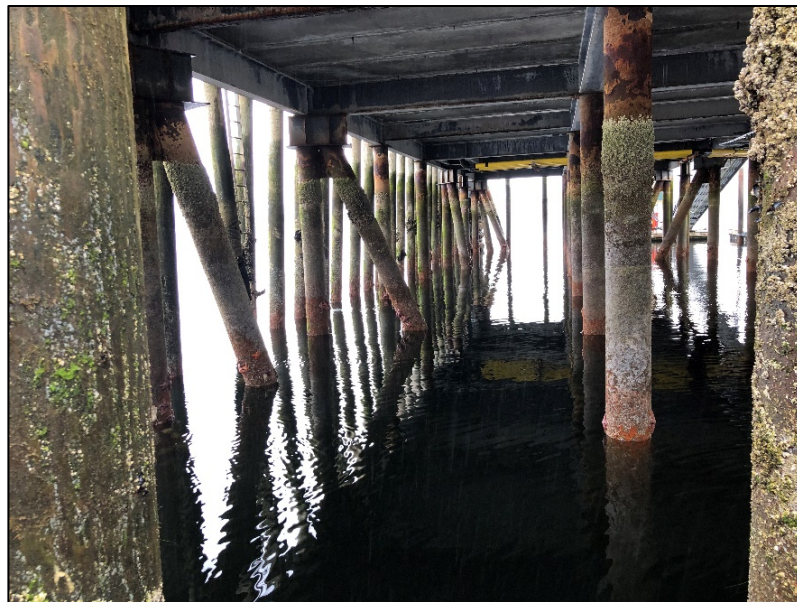
- **Steel Support Piles** – In the splash zone and below, nearly all of the original protective coatings on the steel pipe piles is gone and pile base metal is actively being lost due to the absence of any corrosion protection system. However, at this point in time only minimal loss of pile base metal was measured and similar conditions were observed during the dive inspection at the lower tidal elevations and at mudline. The top 5-ft of pile, near the pile to pile cap connection, is corroded with heavy rust scale appearing on all sides of the pile. Galvanized coatings in this zone are in poor condition, but base metal remains intact.

Overview of steel support piles under the dock.

- **Steel Piles and Superstructure** – The facility is over 20 years old and is in need of attention to maintain and/or extend the intended design service life. In particular, the protective coatings for virtually all steel components have exceeded their useful life and are no longer serving their intended purpose. Of chief concern is steel section loss due to corrosion which translates to reduced structural capacity which would in effect render the dock unsafe and not useable. As a minimum and the short-term goal should be to install adequately sized anodes on all steel piles.

In the long-term, more comprehensive repairs should be done to protect the piles and dock superstructure. The environment, and consequently the condition of the protective coatings, varies with elevation along the piles. Therefore, it is recommended that providing corrosion protection for the dock and dolphin piles should consist of a three-part system. In the intertidal and submerged zones, it is recommended that sacrificial anodes be installed to effectively reduce the rate of corrosion. Secondly, in the splash zone, it is recommended that petroleum pile wraps with protective outer jacketing be utilized. This system has a proven history of effectively sealing off oxygen which significantly reduces the rate of corrosion. Finally, for the areas where the piles transition to the pile caps and the pile caps themselves, it is recommended the steel be blasted, spray metalized and top-coated with a clear protective layer.

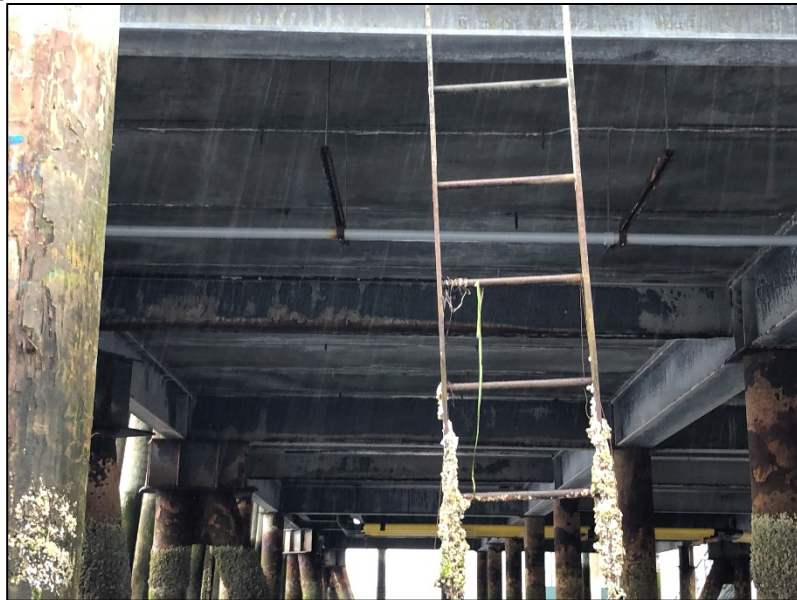
- **Steel Pile Caps and Diaphragms** – The steel pile caps and diaphragms are generally in fair to good condition. Galvanized coatings at the pile to pile cap connection (area where field welding was performed) are gone and base metal is coated with heavy surface rust. In many locations the lower pile cap flange is rusted full-length of the beam.

Typical steel dock framing under dock.

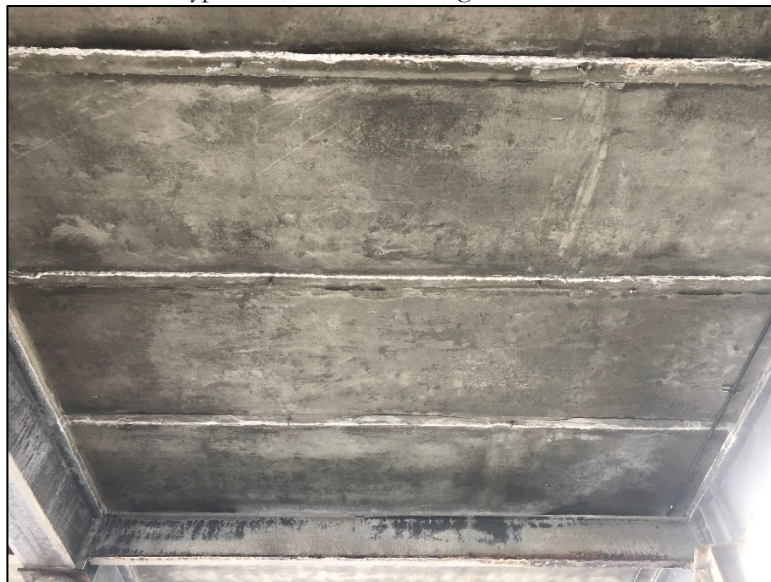
- **Concrete Deck Panels** – The concrete deck panels are in good condition with no damage observed nor any evidence of structural deterioration.

Typical concrete deck panels under dock.

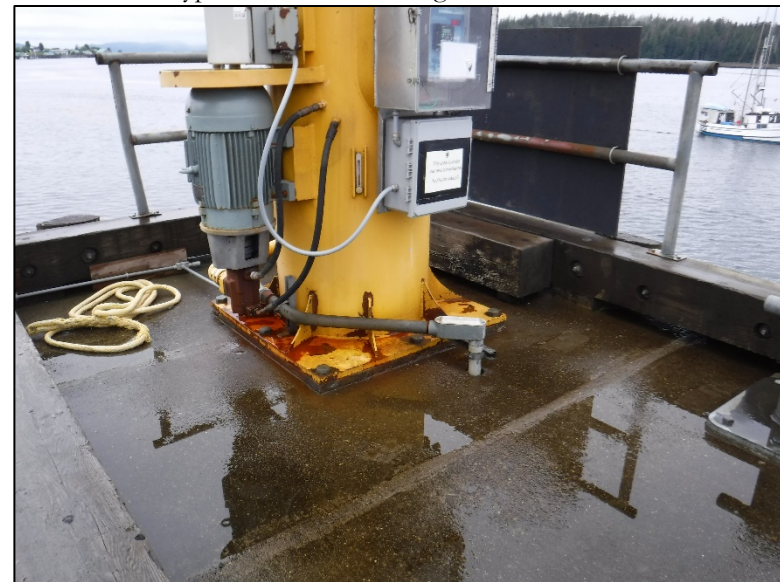
- **Crane** – The crane base and connection to the dock is in good condition. Operation of the crane was not within the scope of work and thus was not inspected.

Crane base on concrete deck.

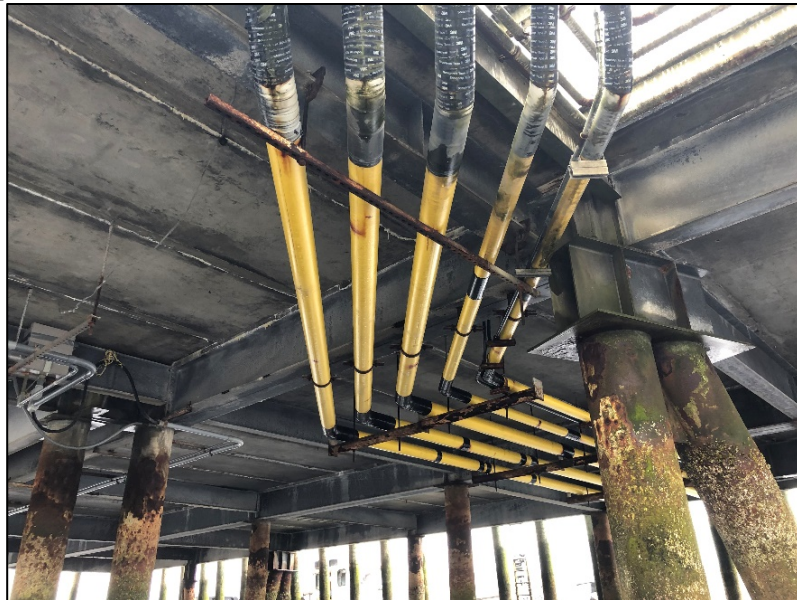
- **Utilities** - The utility connections under the dock are in fair to poor condition. The steel uni-strut supports are heavily corroded due to their close proximity to the water.

Fuel line routing under dock at approach/main dock junction.

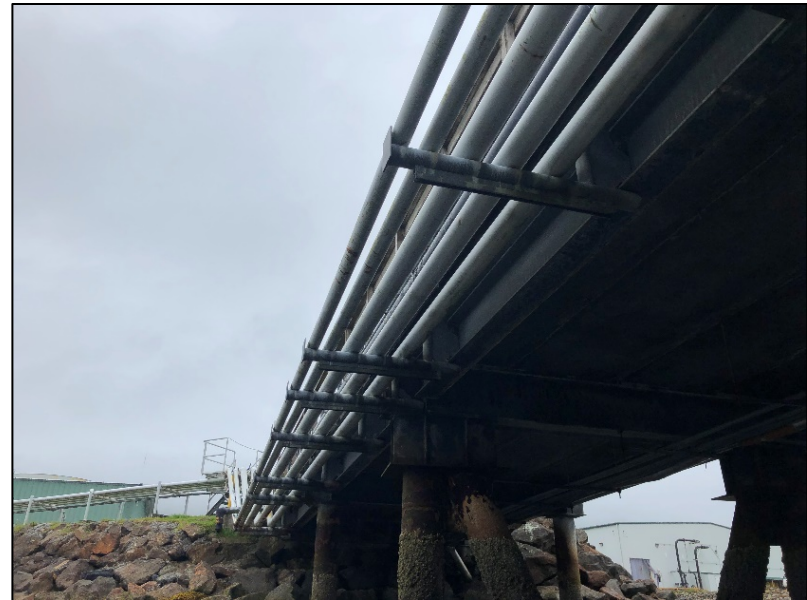
Fuel line routing alongside approach dock (north side).

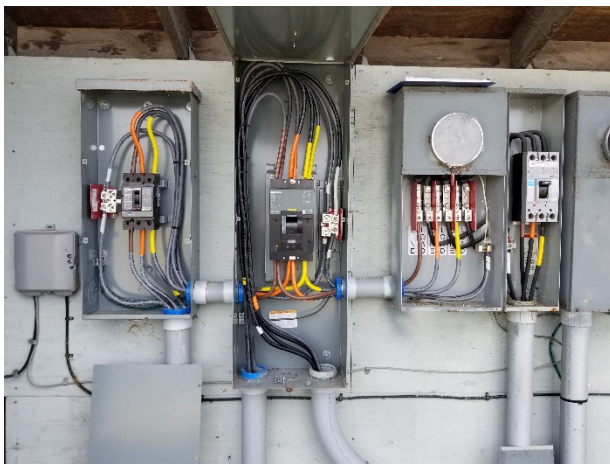
Photo 2: Ice House Service Circuit Breakers

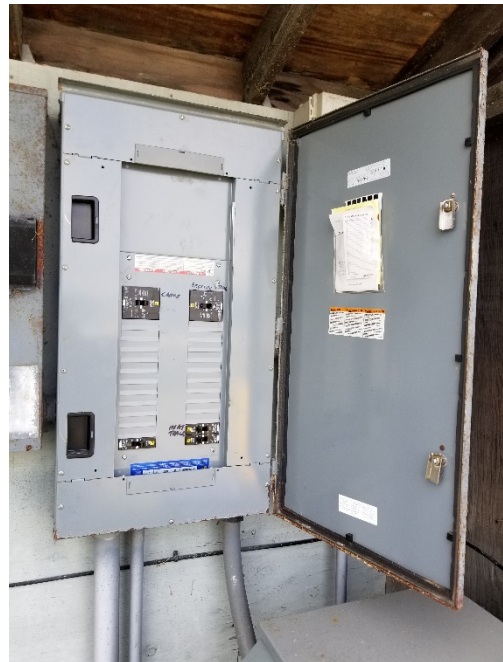
Photo 3: 480 Volt Distribution Panel

3. Distribution Equipment: The distribution panel is in good condition and has capacity for additional loads.
4. Stepdown Transformer and Panelboard: The stepdown transformer is in good condition. The panelboard on the exterior is in fair condition with some corrosion started on the enclosure. The meter for the panelboard is redundant to the meter ahead of the distribution panel. It should be confirmed that the loads to the panelboard are not being double billed.

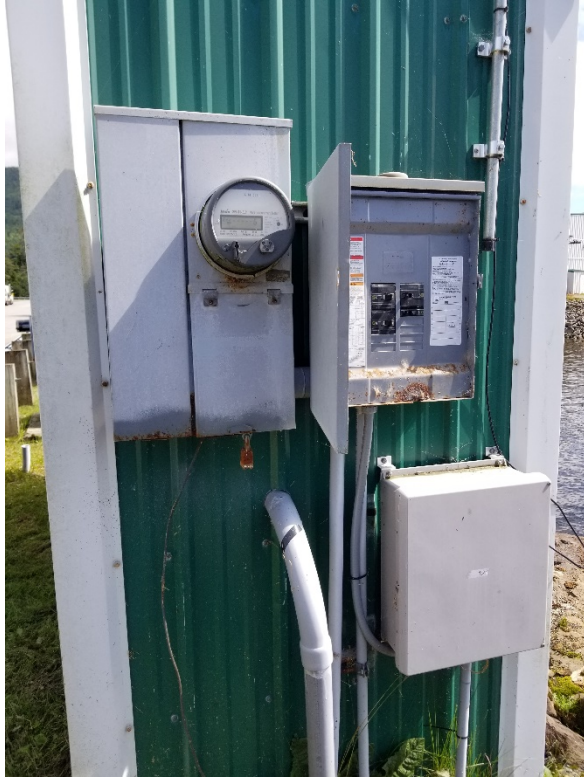
Photo 4: Service Equipment and Panelboard for Refrigerated Containers

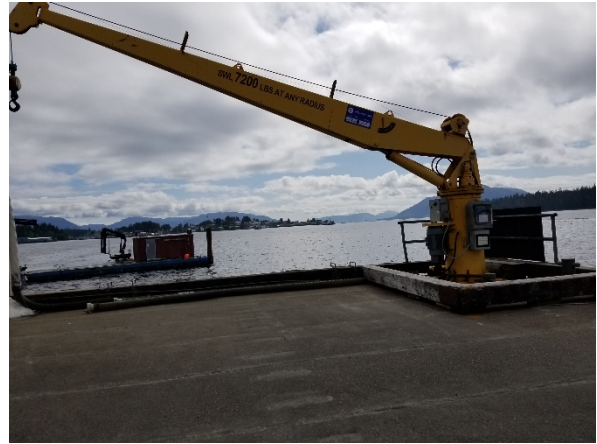
Photo 5: Dock Crane

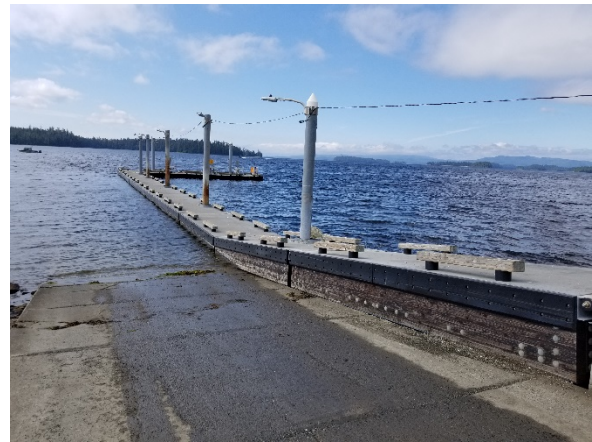
Photo 6: Boat Launch Lighting
